# Good Practice Case Study

# 19

**South Staffordshire Water Company, Green Lane, Walsall.**  
**New offices designed to maximise natural lighting and minimise heating requirements.**

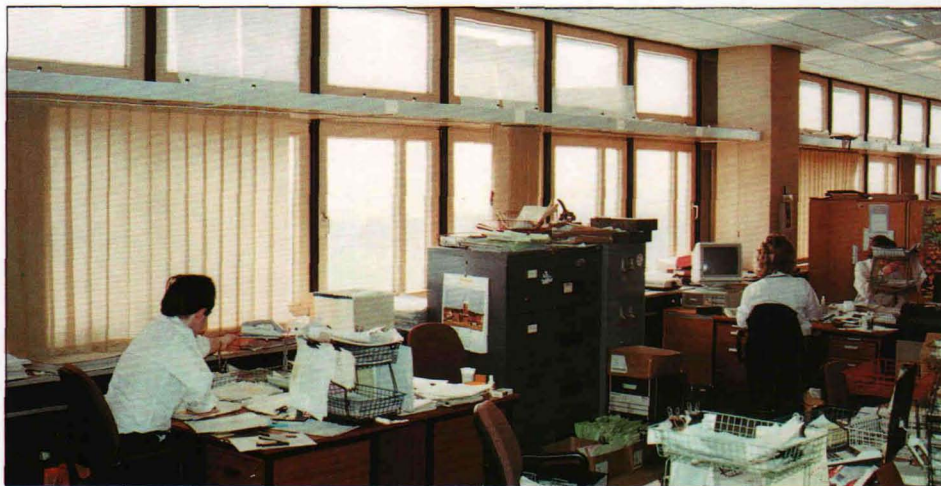
**Interior view showing solar protection**

The building has a north-south diagonal in order to allow some sun into all the windows. A complex window design with overhangs and internal and external "light shelves" cuts solar heat in summer and evens-out the distribution of daylight and sunlight.

The smooth gradation of light feels comfortable and stops people wanting electric lights on to compensate for an excessively bright perimeter. Low winter sun through the upper parts of the window which do not have blinds occasionally causes glare.
